Tesla, Inc. Service Bulletin		<i>Insulate A/C Low Pressure Pipe and Install Harness Connector Cover</i>	
SB-21-18-007 R3 June 24, 2022		R3	
Classification		Section/Group	Mobile Service
Campaign Bulletin		18 - Thermal Management	Can Perform (where permitted)
Model Year	Model	Country/Region	Version
2021	Model 3, Model Y	China, Europe	All
<small>The model(s) and model year(s) listed are a general approximation of the affected VIN list. Refer to the VIN/Bulletin Tracker or Customer/Vehicle profile to determine applicability of this bulletin for a particular vehicle.</small>

Condition

Certain Giga Shanghai built Model 3 and Model Y vehicles might experience water condensation dripping from the A/C low pressure pipe onto the A/C compressor HV harness connector.

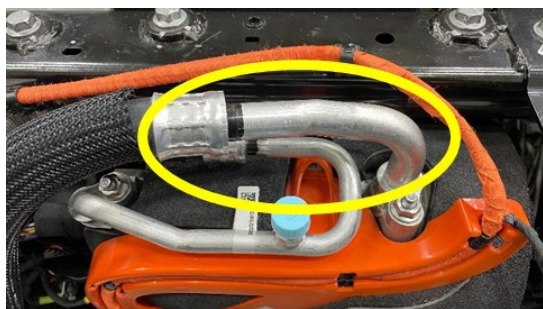
Figure 1- Foam Not Installed (China)

Inspect the low pressure pipe (Figures 1 and 2 for China, and Figures 3 and 4 for Europe) and the harness connector at the A/C compressor (Figures 3 and 4).

- If insulation foam is already installed, install the AC compressor harness connector cover (refer to section “*Install the A/C Compressor Harness Connector Cover*” in this document).
- If insulation foam is not installed, insulate the A/C compressor low pressure pipe, and install the harness connector cover (refer to section “*Insulate A/C Compressor Low Pressure Pipe and Install Harness Connector Cover*” in this document).
