Tesla, Inc. Service Bulletin		<i>Install O-ring on Trunk Power Strut</i>	
SB-22-11-001 July 28, 2022			
Classification		Section/Group	Mobile Service
Campaign Bulletin		11 - Closures	Can Perform (where permitted)
Model Year	Model	Country/Region	Version
2021	Model 3	All	All
<small>The model(s) and model year(s) listed are a general approximation of the affected VIN list. Refer to the VIN/Bulletin Tracker or Customer/Vehicle profile to determine applicability of this bulletin for a particular vehicle.</small>

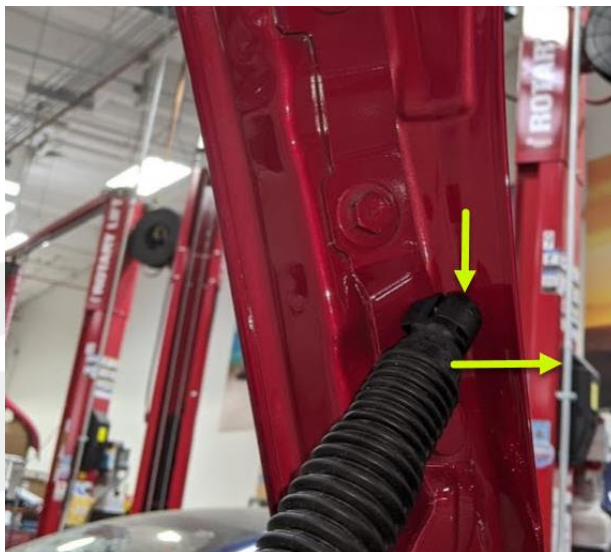
Figure 1

1. Open the trunk.
2. Release the C-clip that attaches the upper end of the trunk power strut to the trunk lid, and then separate the power strut from the trunk lid ball stud (Figure 1).

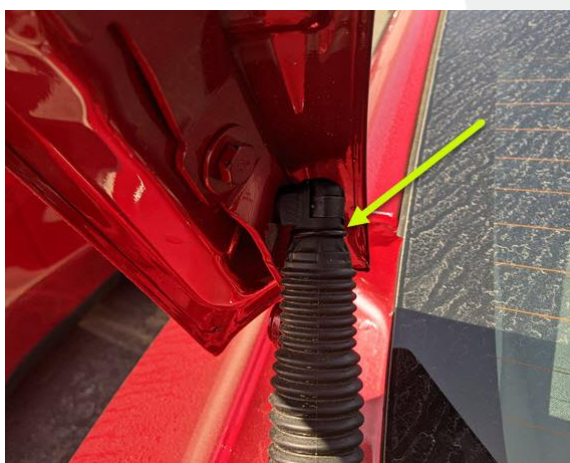
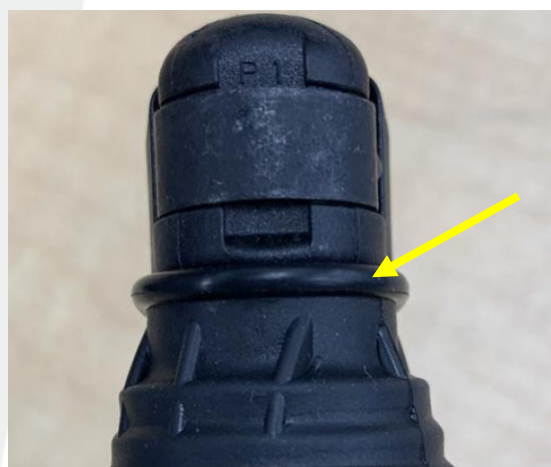
Figure 2

3. Inspect the LH trunk power strut for the presence of an O-ring on top of the strut bellows (Figures 2 and 3). If an O-ring is found present, remove and discard it.

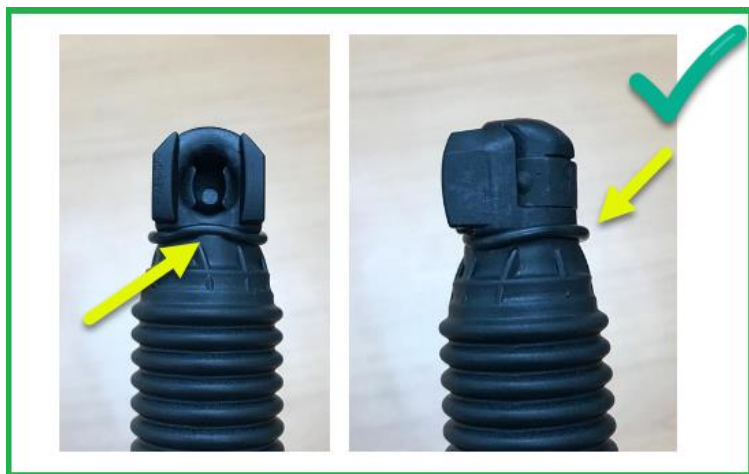
4. Install an O-ring onto the power strut: roll the seal over the top of the power strut and fit it between the bellows and the ball stud socket (Figure 4).

Figure 4 – O-ring seated correctly

⚠ CAUTION: Make sure that you install the correct O-ring with part number 1831785-00-A.

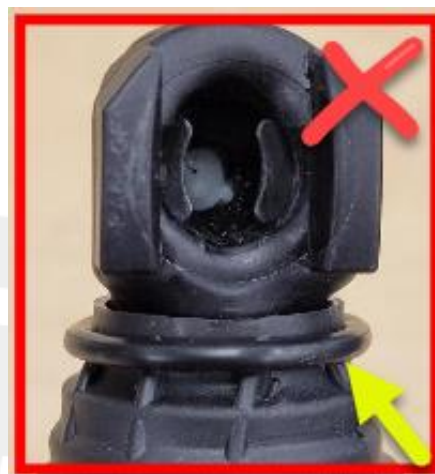
⚠ CAUTION: Do not install the O-ring over the top of the bellows (Figure 5).

Figure 5 - O-ring seated too low

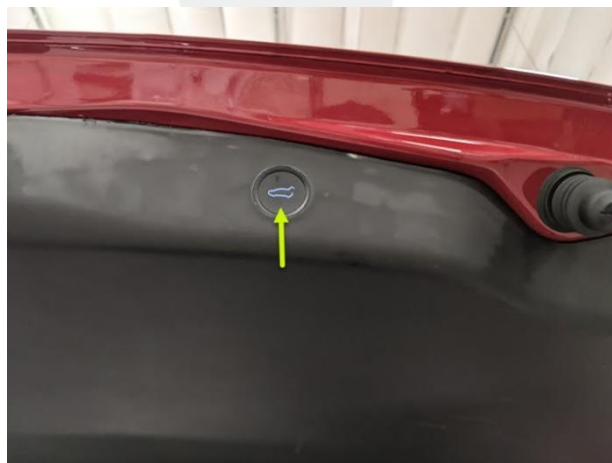
Figure 6

6. Close the power trunk from the power trunk switch (Figure 6).
